Final
Report

March 1972

Composite Overwrapped Metallic Tanks

MARTIN MARIETTA CORPORATION

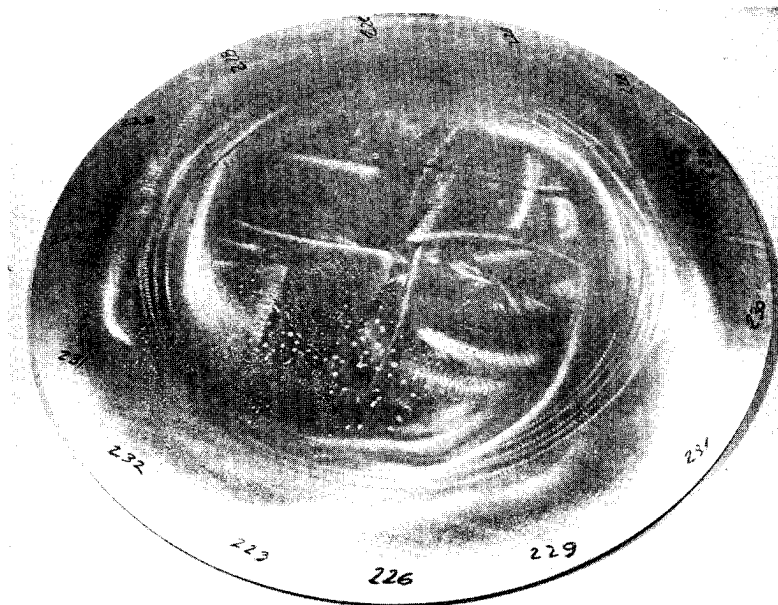
The raw material as received from the supplier contained numerous surface defects and, even though bought to commercial standards, part of the shipment was returned to the supplier for poor workmanship. The variations in flatness from the edge to the center of a sheet, though within specification requirements, made it very difficult to work in the explosive-forming process. Attempts to machine the surfaces to a close tolerance were not successful because of the inability to hold the material flat. In general, it is concluded that the poor quality of the material (see Section B) had a major bearing on the program's lack of success (Fig. 3, 4, and 5).

Figure 3 Explosive-Forming Titanium Blank Showing
Rolled-In Defects and Surface Pitting Remaining
After Attempts to Grind the Surface under a
Coolant

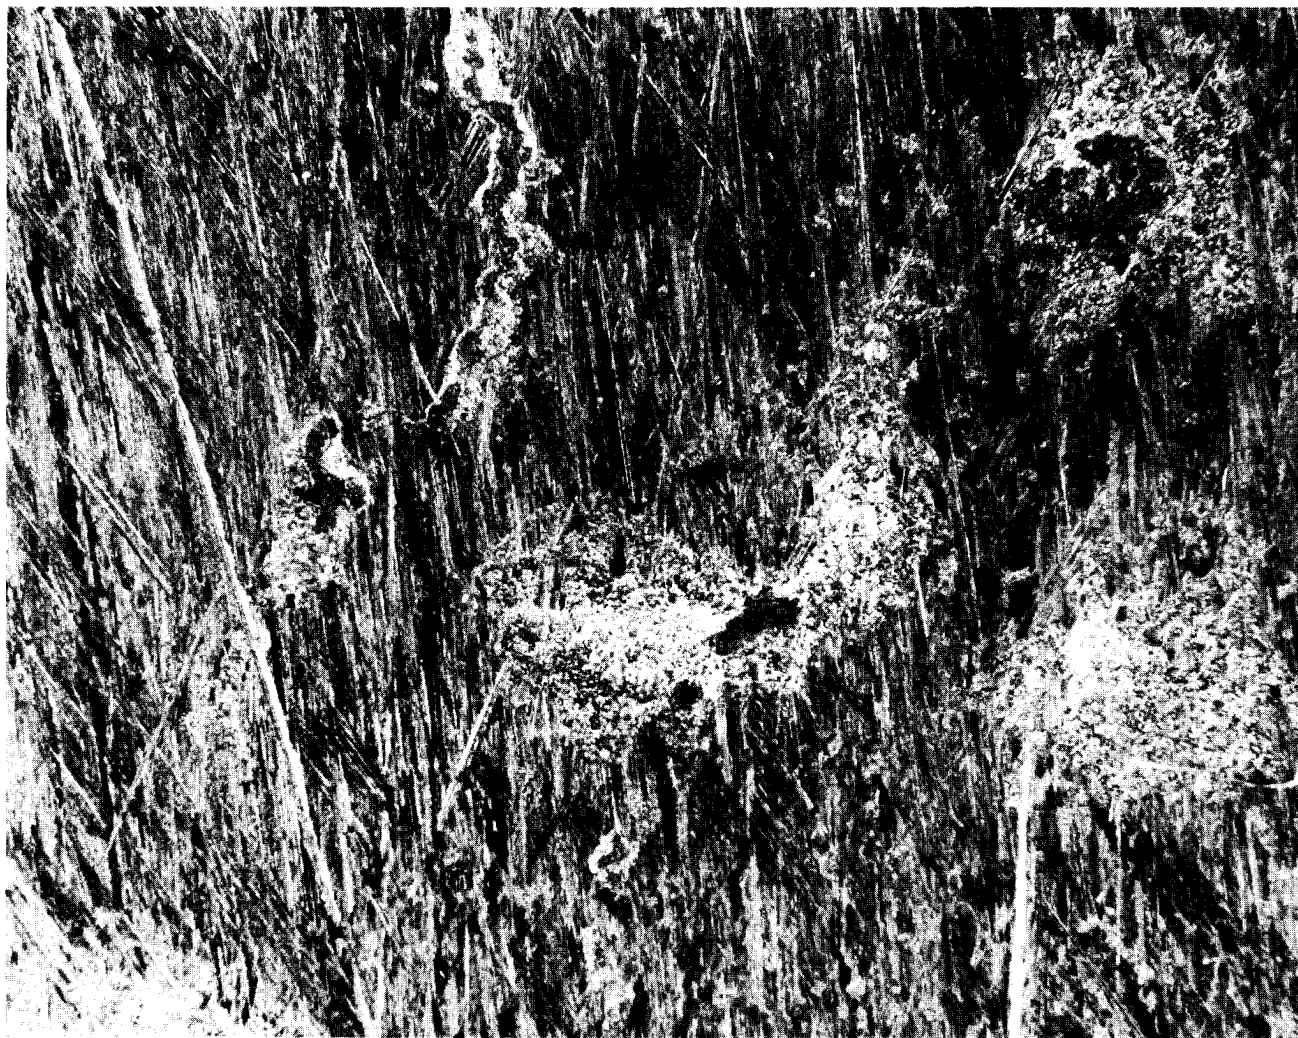
Figure 4 Macrophotograph (Approximately 10X) of Rolled-In Surface Defects in Titanium Plate Shown in Figure 3

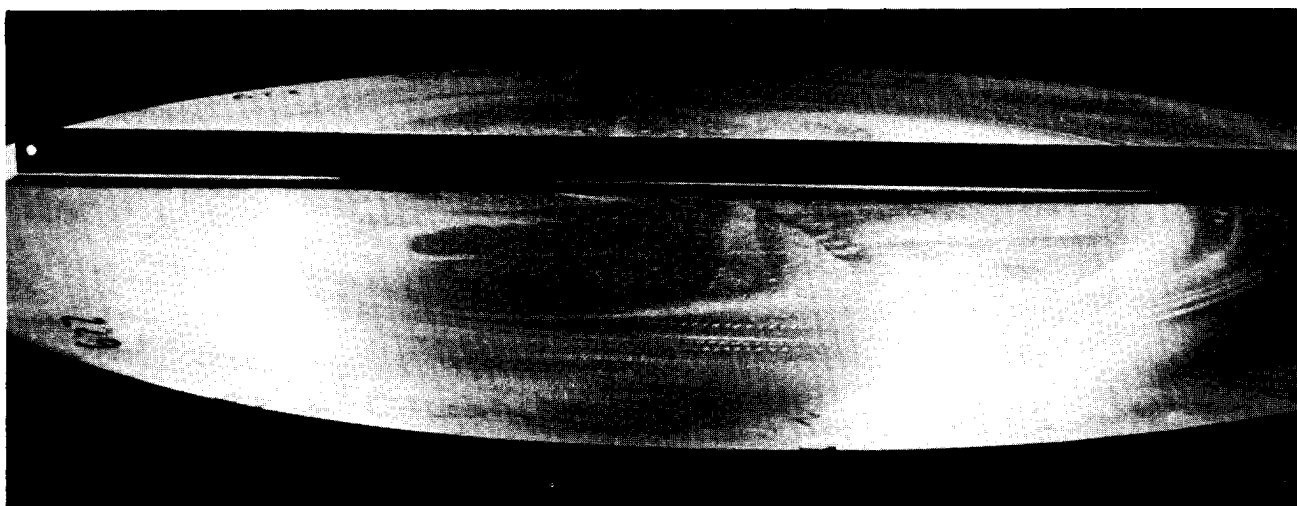
Figure 5 Explosive-Forming Blank (Same as Fig. 3 and 4) Illustrating Deviation From Flatness

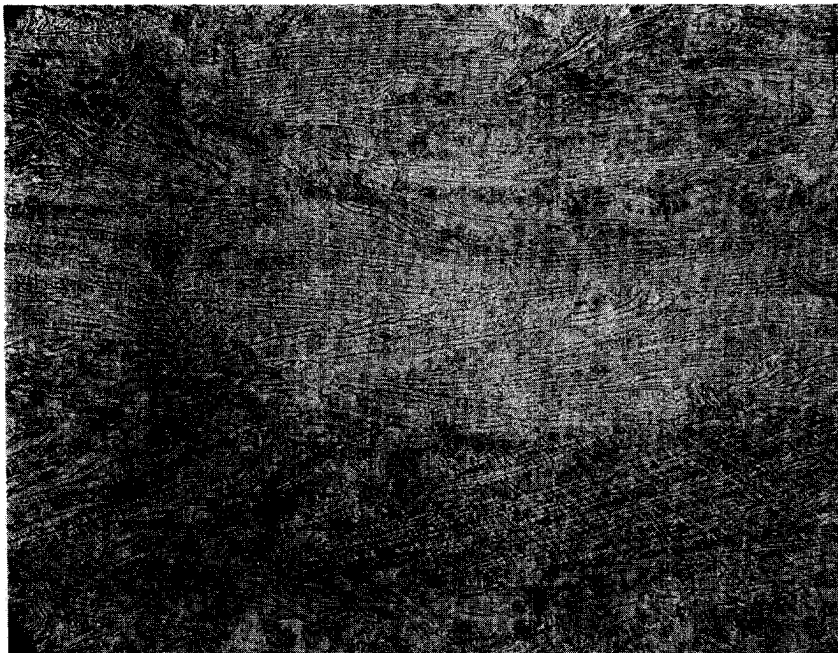
A metallurgical investigation as to the cause of failures was then undertaken. The normal cause for forming failures in titanium (a hard face-oxidized surface and contamination) was suspect. Investigation revealed that improper annealing by the producer rather than contamination was the cause. Mill records were studied and it was determined that one group of the plates had been annealed at 1500°F for 30 minutes and the second group at 1500°F for 15 minutes. While normal tensile tests did not reveal the lack of a proper anneal, the photomicrographs left no doubt as to the material condition. Photomicrographs (Fig. 7 and 8) show the heavily textured grain structure with no indication of alpha surface scale. All the formed domes listed in Tables 1 and 2 exhibited crosshatched microcracks (Fig. 9). The crosshatched microstructure automatically scrapped all domes that had been produced to this point even though they did not indicate conditions of surface cracking. The normal equiaxial grain structure for this alloy is shown in Figure 10.

Figure 7 Photomicrograph of Cross Section at 100X from Failure Area of Dome C-2 Showing Hot Roll Texture

Attempts to return the material to the producers were fruitless and, since replacement appeared out of the question, it was determined that a proper annealing cycle must be developed to salvage the remaining material. This was accomplished, and a period of four hours at 1650°F in a vacuum followed by a furnace-cool proved to be the optimum cycle. The full report of the failure analysis and supporting technical data may be found in the appendix. The ABAR vacuum furnace at the Denver Division facility was not large enough to economically anneal the blanks. The only other suitable, certified vacuum furnace in the area was located some 60 miles away in Colorado Springs at the Proto Shop. This furnace, an Ipsen, contained automatic controls, proper temperature and pressure readouts, and recording equipment. After thoroughly discussing the problem, arrangements were made with the very cooperative Proto Shop management to give the titanium annealing effort first priority. A maximum effort to properly anneal the material for explosive forming and to provide "in process" annealing between shots was undertaken. The annealing for the remaining supply of blanks began on April 23 and was completed on May 23. In the meantime, blanks were being given their first explosive-forming shots, process annealing, and second shots, etc, as rapidly as

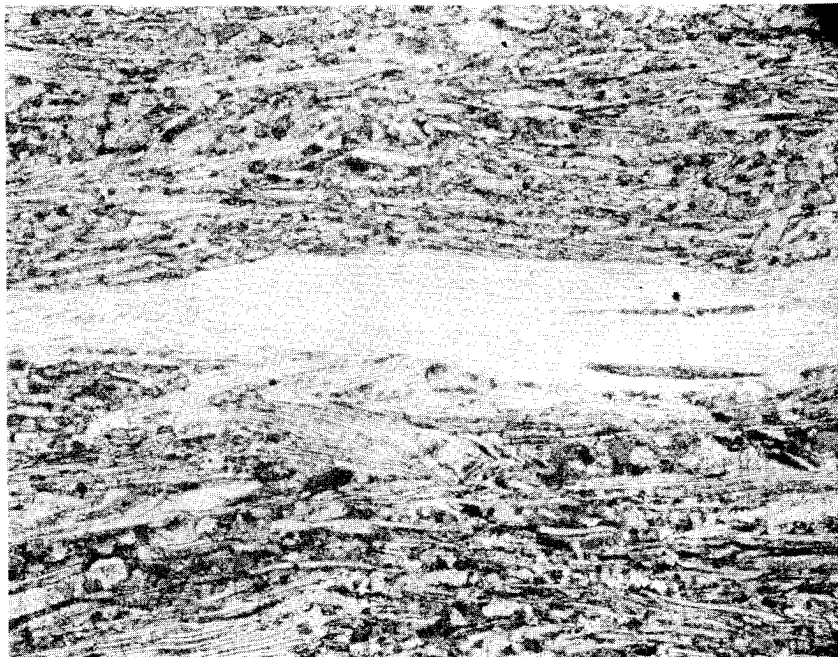
Figure 8 Photomicrograph of Longitudinal Cross Section at 100X of As-Received "C" Plate

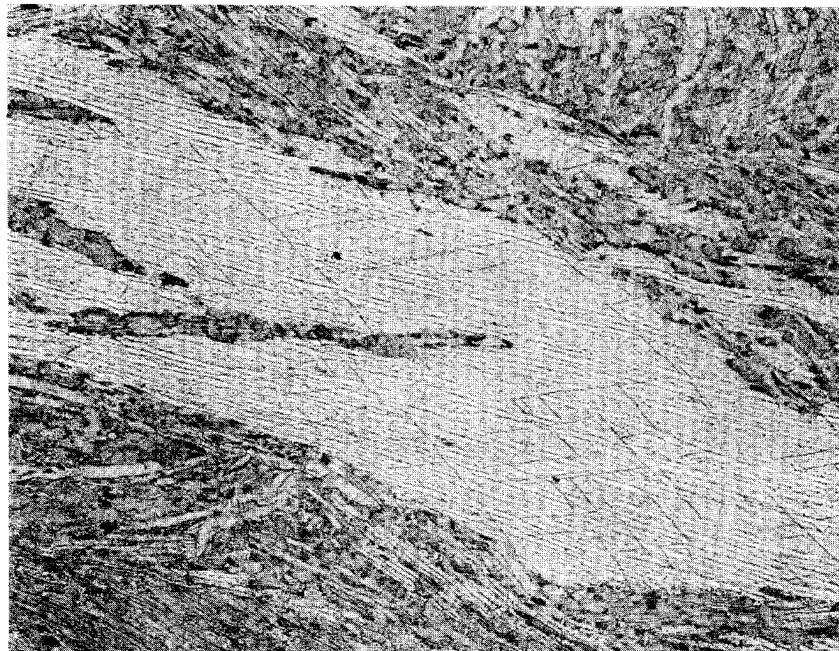
Figure 9 Photomicrograph of Cross Section at 100X from Failure Area of Dome D-3 Showing Crosshatch Cracking

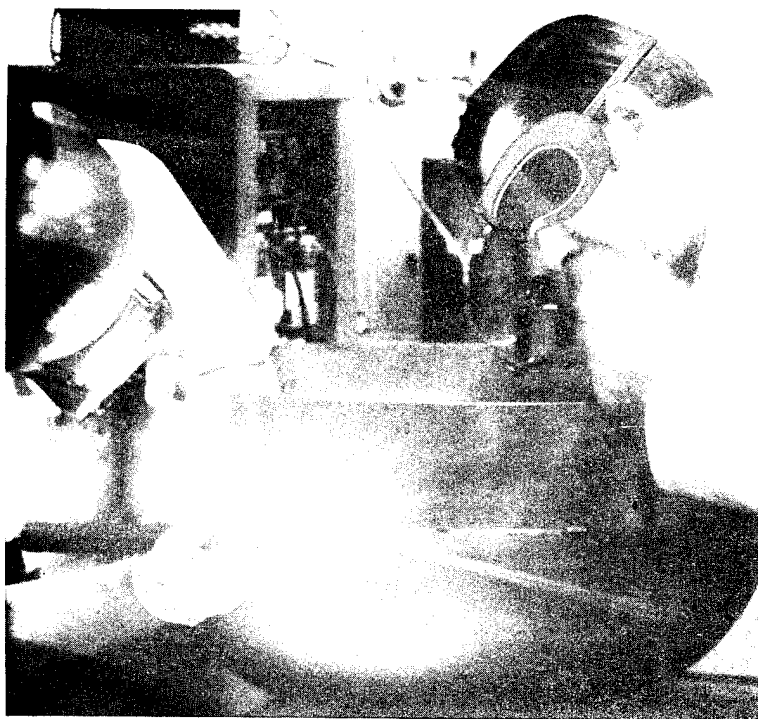
After selecting two matched dome subassemblies, a barrel was rolled, trimmed to fit, and machined for welding. Because there was no provision for access to the final tank closure weld, internal tooling could not be used. The design was therefore engineered to provide an interlocking step joint at the dome-to-barrel interface. This idea was employed to replace the normal weld backup tooling concept. As anticipated, fitup problems occurred (Fig. 33). After S/N 1 failed because of lack of fusion in this joint, a butt joint was determined necessary to eliminate fit and, hopefully, lack of fusion problems. Although the butt joint presented no machining or fit problems, it became necessary to TIG-tack the assembly at about 4-inch intervals around the circumference to hold it together prior to electron beam welding. Slight but acceptable porosity and tungsten inclusion difficulties appeared on X-rays from the TIG tacking (Fig. 34).

Figure 34 TIG Surface-Tack Weld of Barrel-to-Dome
Prior to Performing Electron Beam Weld

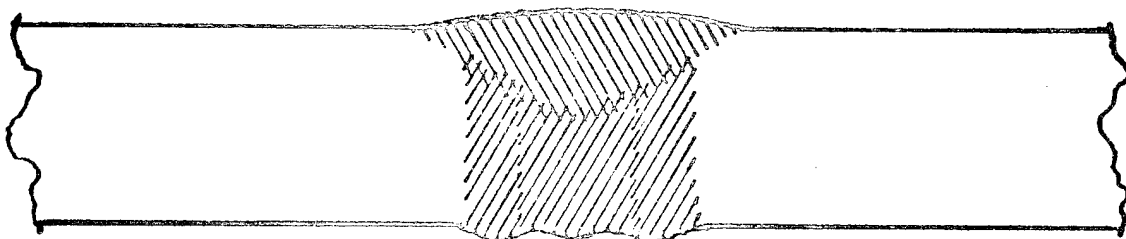
Electron Beam Weld Off ϕ of Joint

Figure 35 Defective Single-Pass Electron Beam Weld and Proper Triple-Pass Weld

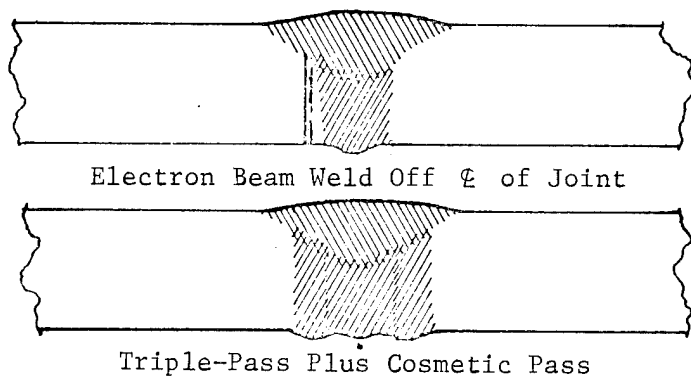
Figure 58 Defective Single Pass Electron Beam Weld and Proper Triple-Pass Weld

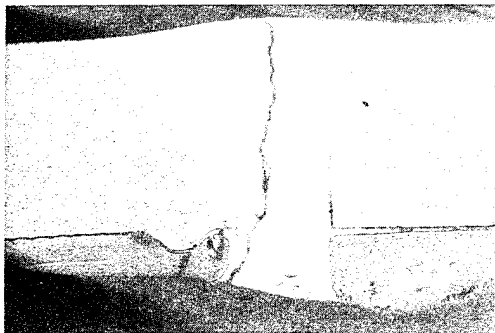
Figure 59 S/N 3 Failure in Girth Joint due to Weld Contamination

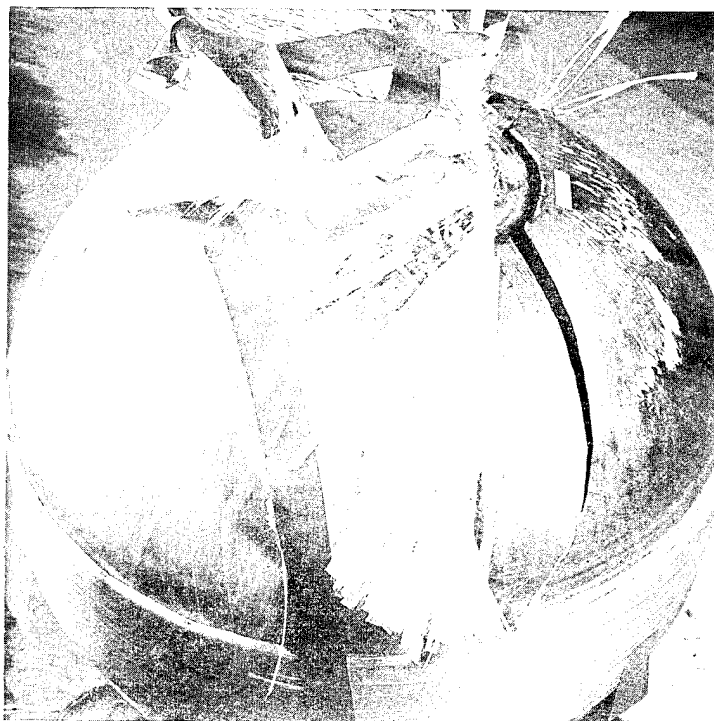
Figure 60 Photograph of S/N 4 Tank Showing Fracture After Removal of Fiber-glass

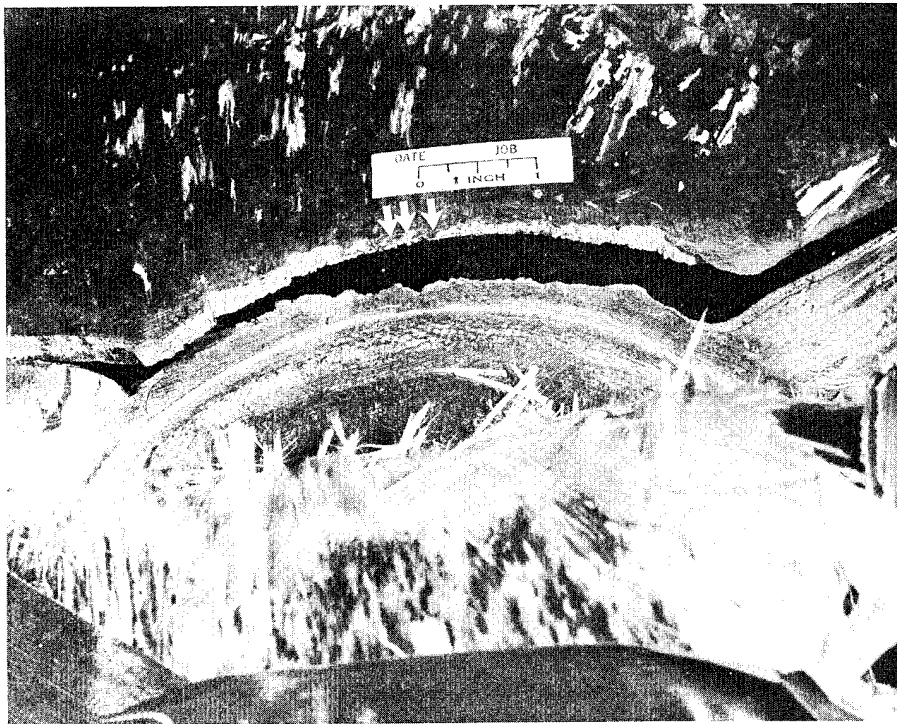
Figure 61 Photograph of S/N 4 Showing Weld Fracture
With Arrows Indicating Approximate
Origin of Failure

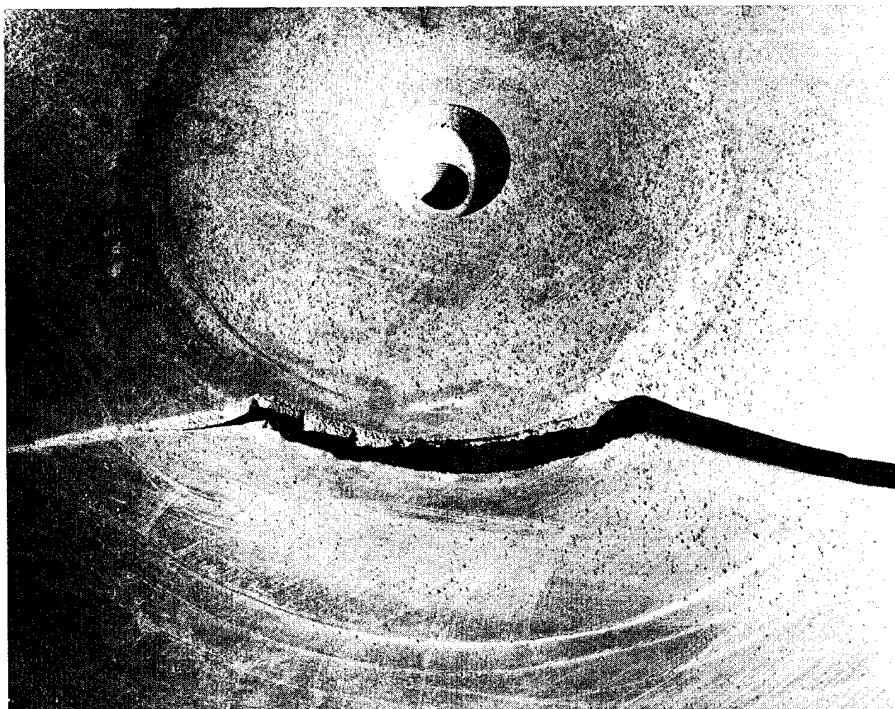
Figure 62 Photograph of S/N 4 Fracture from
Inside the Tank

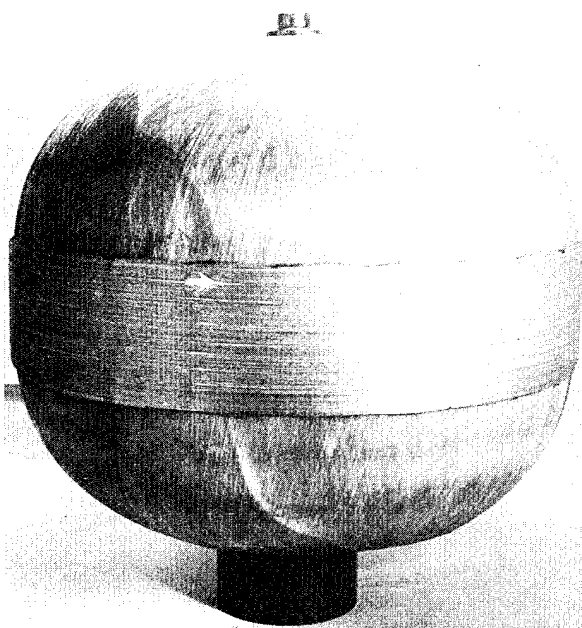
S/N 5 failed at 3660 psi during the hydrostatic sizing operation (Fig. 64). This is the only tank that failed in the longitudinal joint of the cylindrical band (Fig. 65). The failure area appeared to have been contaminated by an iron inclusion when a portion of the carry-through bolt that was a part of the weld tooling partially melted during welding. This was not detected by X-ray (Fig. 66).

Figure 64 Photograph of S/N 5
Showing the As-Failed
Configuration; Arrow
Indicates Approximate
Origin of Fracture

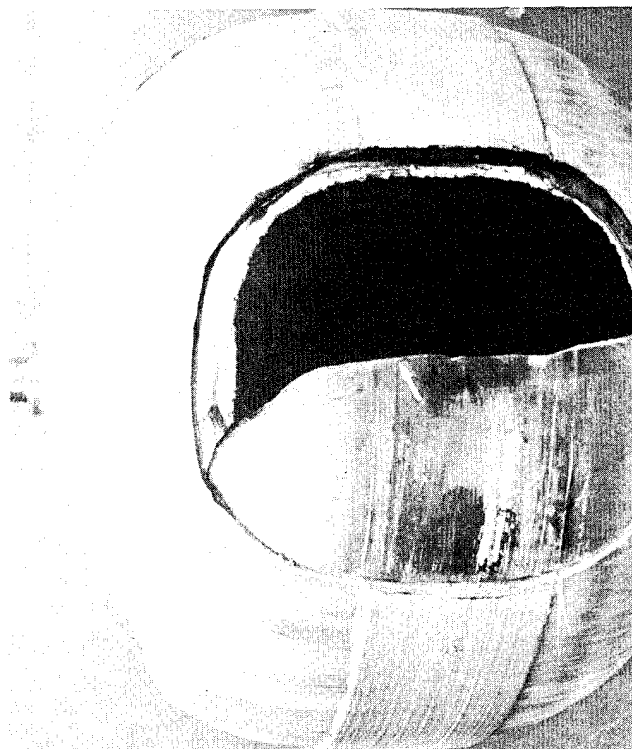
Figure 65 Photograph of S/N 5 Showing
Exposed Fracture Surface;
Arrow Indicates Failure
Origin

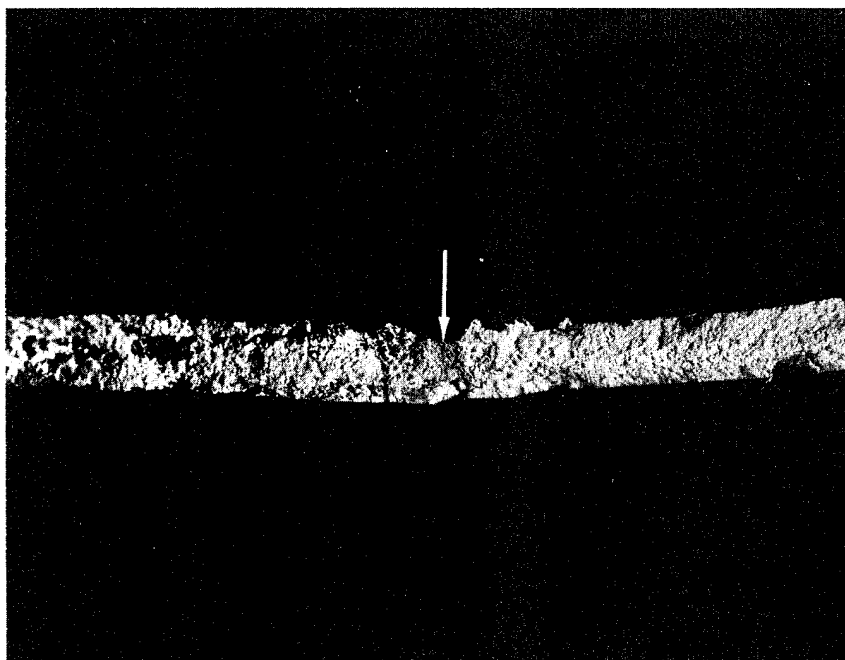
Figure 66 Photomacrograph of Fracture Surface on
S/N 5; Arrow Shows Origin of Failure

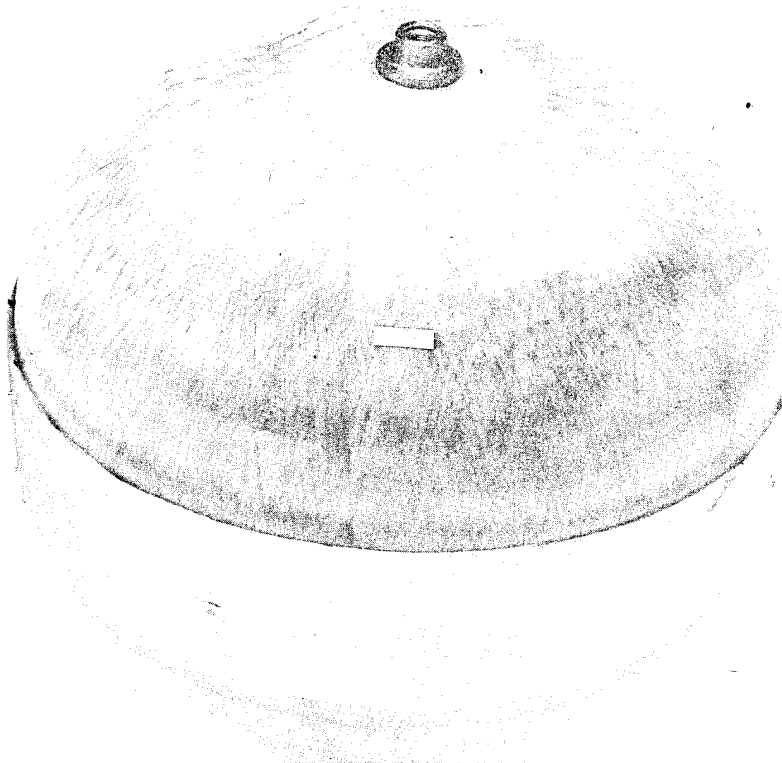
S/N 6 was successfully sized at 4527 psig. Following the hydrostatic sizing, it was checked for volume increase and then cycled at 75°F between 100 and 3360 psi. On the 49th cycle, there was an indication of a probable failure. On the 50th cycle a pressure decay of 21 psig/sec confirmed the failure and the test was stopped. Figure 67 shows the tank as failed and prior to the failure analysis.

Figure 6/ Photograph of S/N 6 Showing As-Failed Configuration

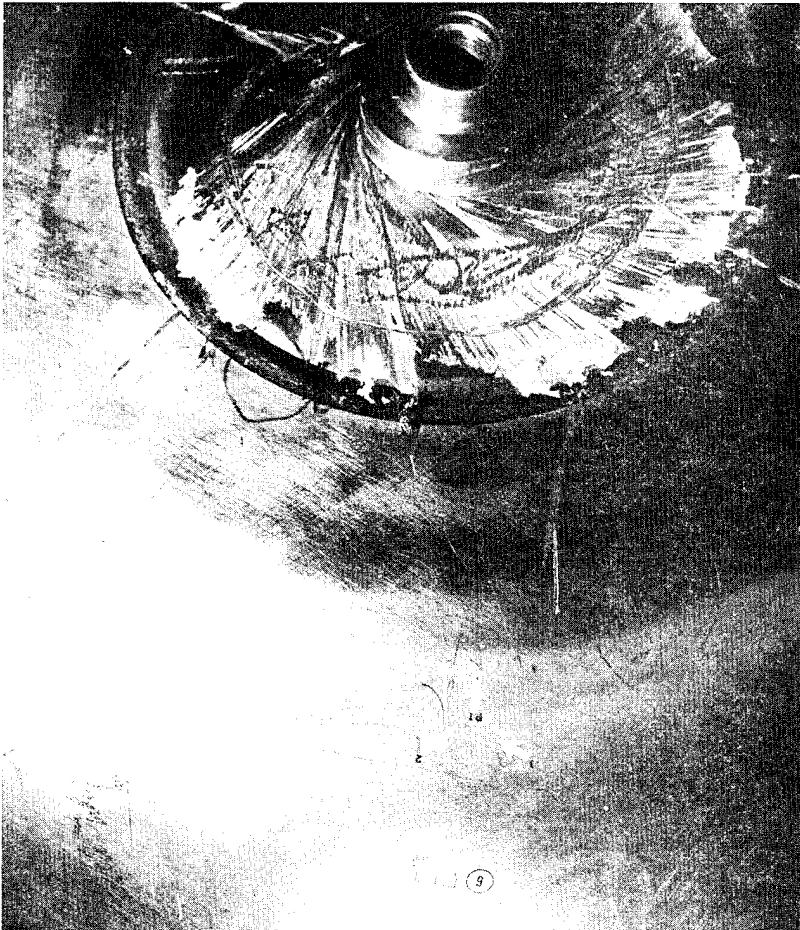
Figure 68 Photograph of S/N 6 Showing
Leak Area

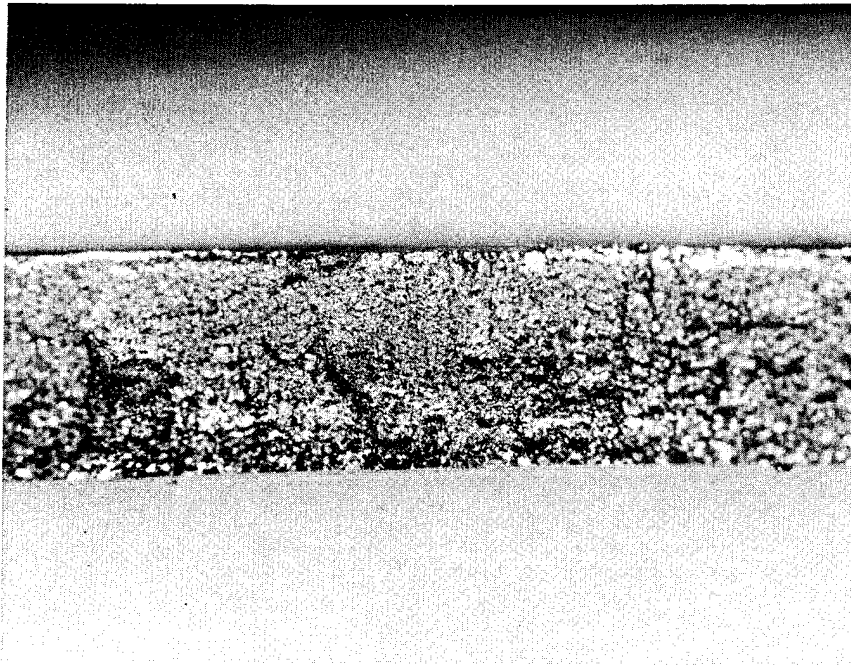
Figure 70 Cross Section of Failure Area on S/N 6
Looking at End of Crack Shown on Figure 67

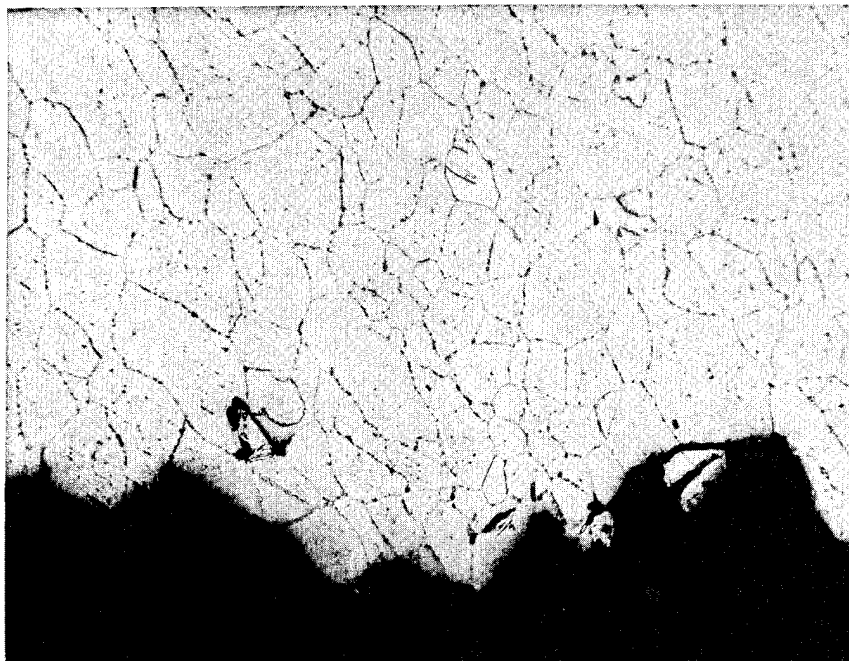
Figure 71 Section of S/N 6 Failure Looking at Edge
of Fracture That Follows Grain Boundaries
(Magnification, 250X)

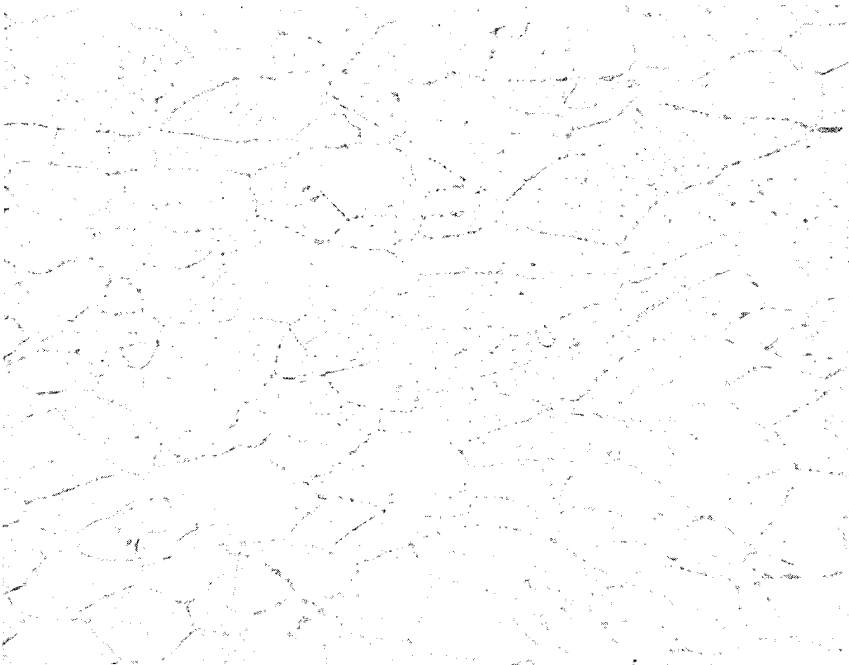
Figure 73 Photomicrograph of the Micro-
structure Through the Leak Area
of S/N 6 (Note the "Dirty"
Microstructure and Grain Boundary
Precipitant, 250X)

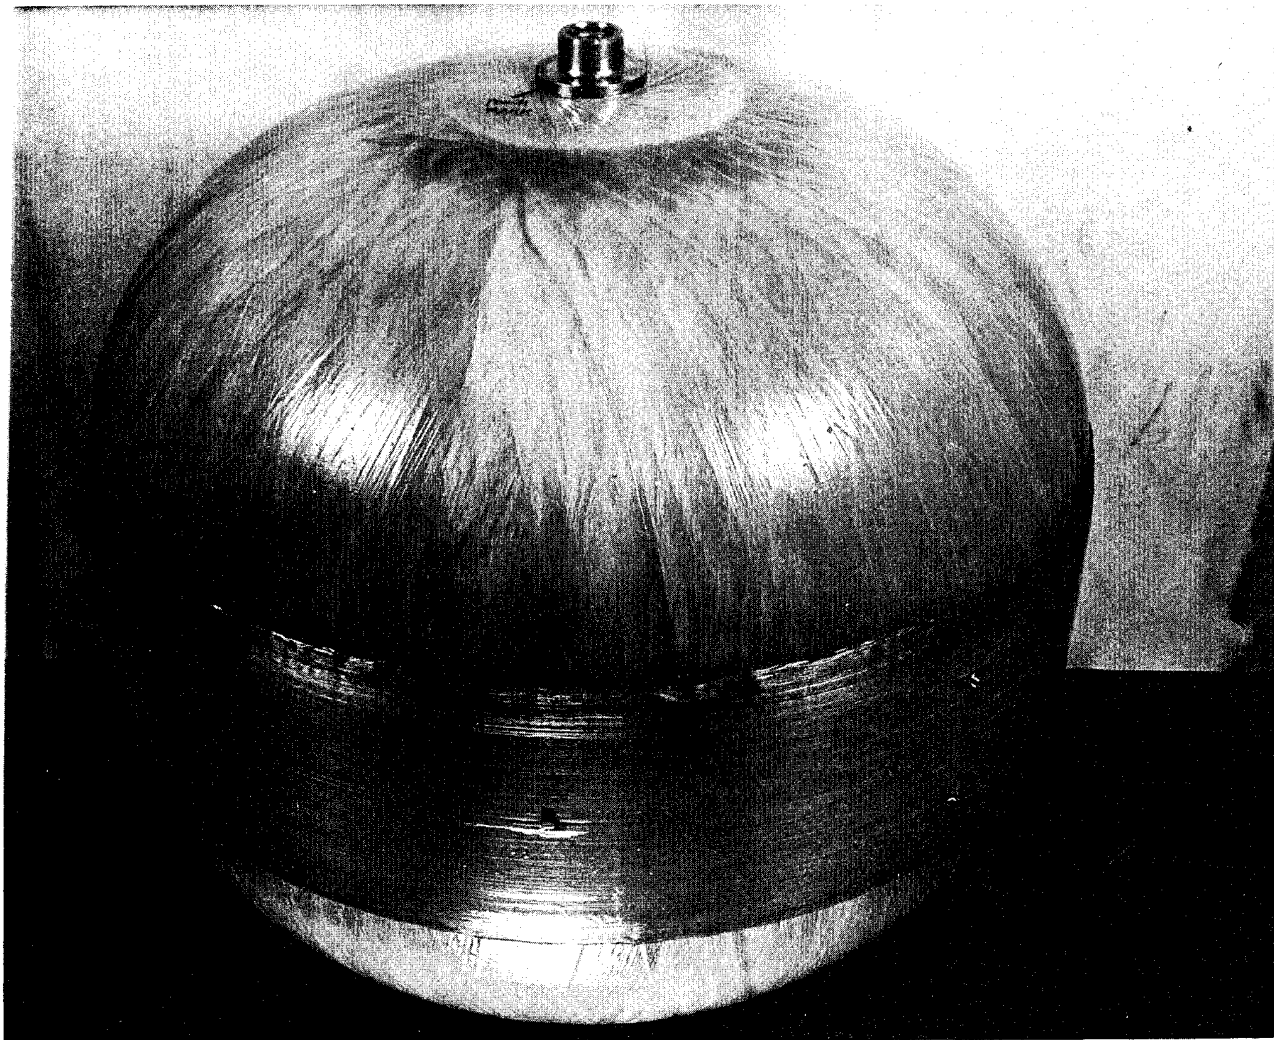
S/N 7 was hydrostatically sized at 4469 psig. The volume after sizing was determined to be 7327 in.³ The vessel was then hydrostatically pressurized at 75°F to burst. The tank failed at 5062 psig (Fig. 74). The failure initiation point was in the girth weld. Analysis indicated the failure was due to simple overpressure with no metallurgical cause for failure.

Figure 74 S/N 7 after Failing at 5062 psi (Note the Lack of Fragmentation or Shattering of Overwrap Material)

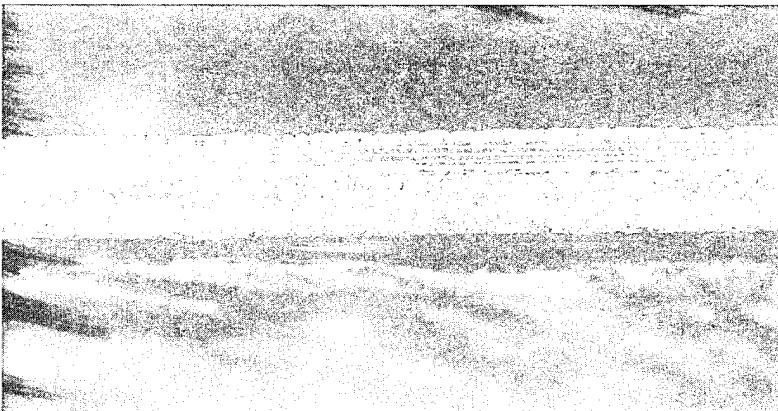
Figure 77 Photomicrograph of S/N 8 Fracture Surface Showing Lack of Fusion at Dome-to-Fitting Joint

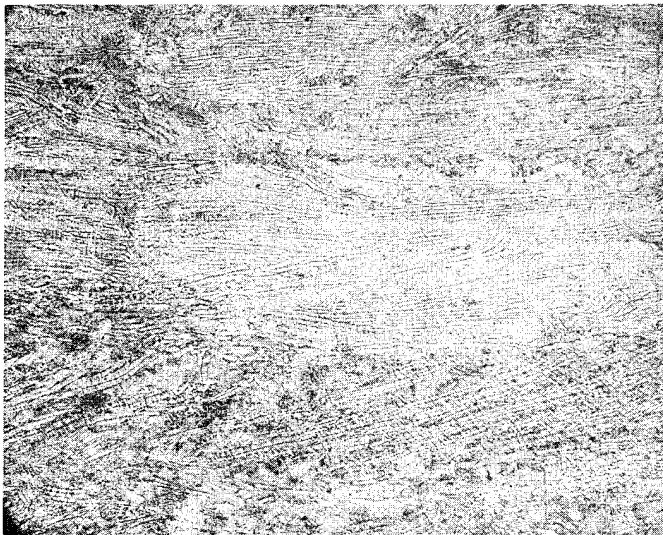
Microexamination of cross sections taken from the failed areas of the two domes C-2 and D-3 revealed no evidence of alpha scale. The microstructure was predominantly hot-rolled-textured (Fig. 1). Several areas of crosshatch cracking were observed in the microstructure near the failed areas (Fig. 2).

Figure 1 Photomicrograph of Cross Section at 100X from Failure Area of Dome C-2 Showing Hot-Roll Texture

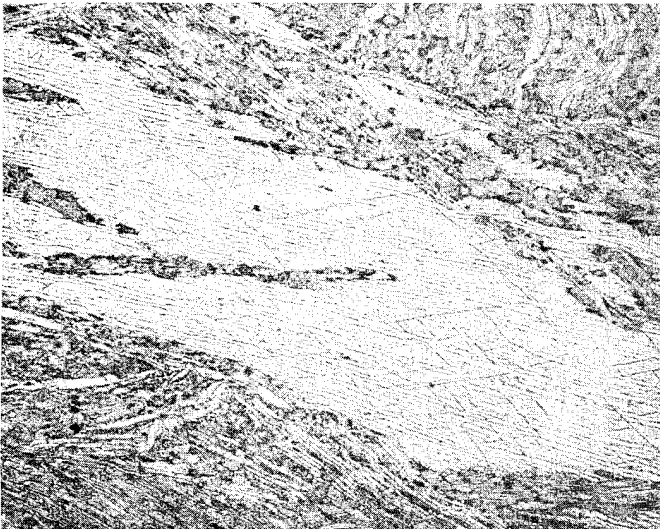
Figure 2 Photomicrograph of Cross Section at 100X from Failure Area of Dome D-3 Showing Crosshatch Cracking

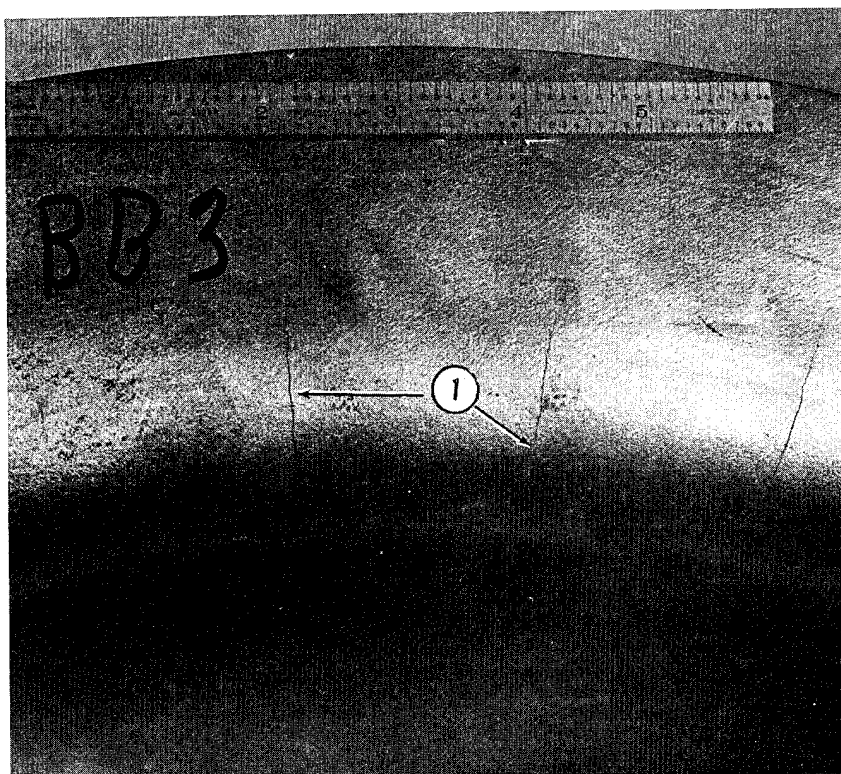
Macroexaminations of the eight cracked domes and specimens from four domes, as-received materials, and as-annealed stock were conducted. In summary, these examinations indicated that an oxygen-rich (stabilized alpha) case was developing on both the inside and outside surfaces of the domes, and that stress corrosion cracking was occurring in some domes. Buckling and stress rupture have not been eliminated as possible causes for the cracks near the apexes of the domes.

Figure 1 Cracks in the Flange Radius of Dome BB3

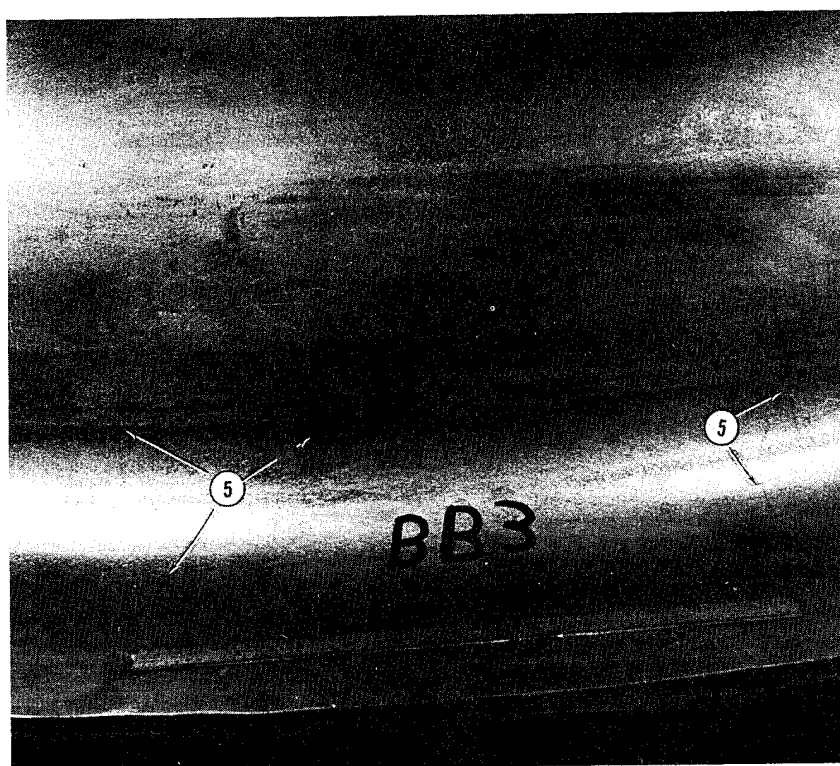
Figure 2 Cracks in the Flange and above the Flange of Dome BB3

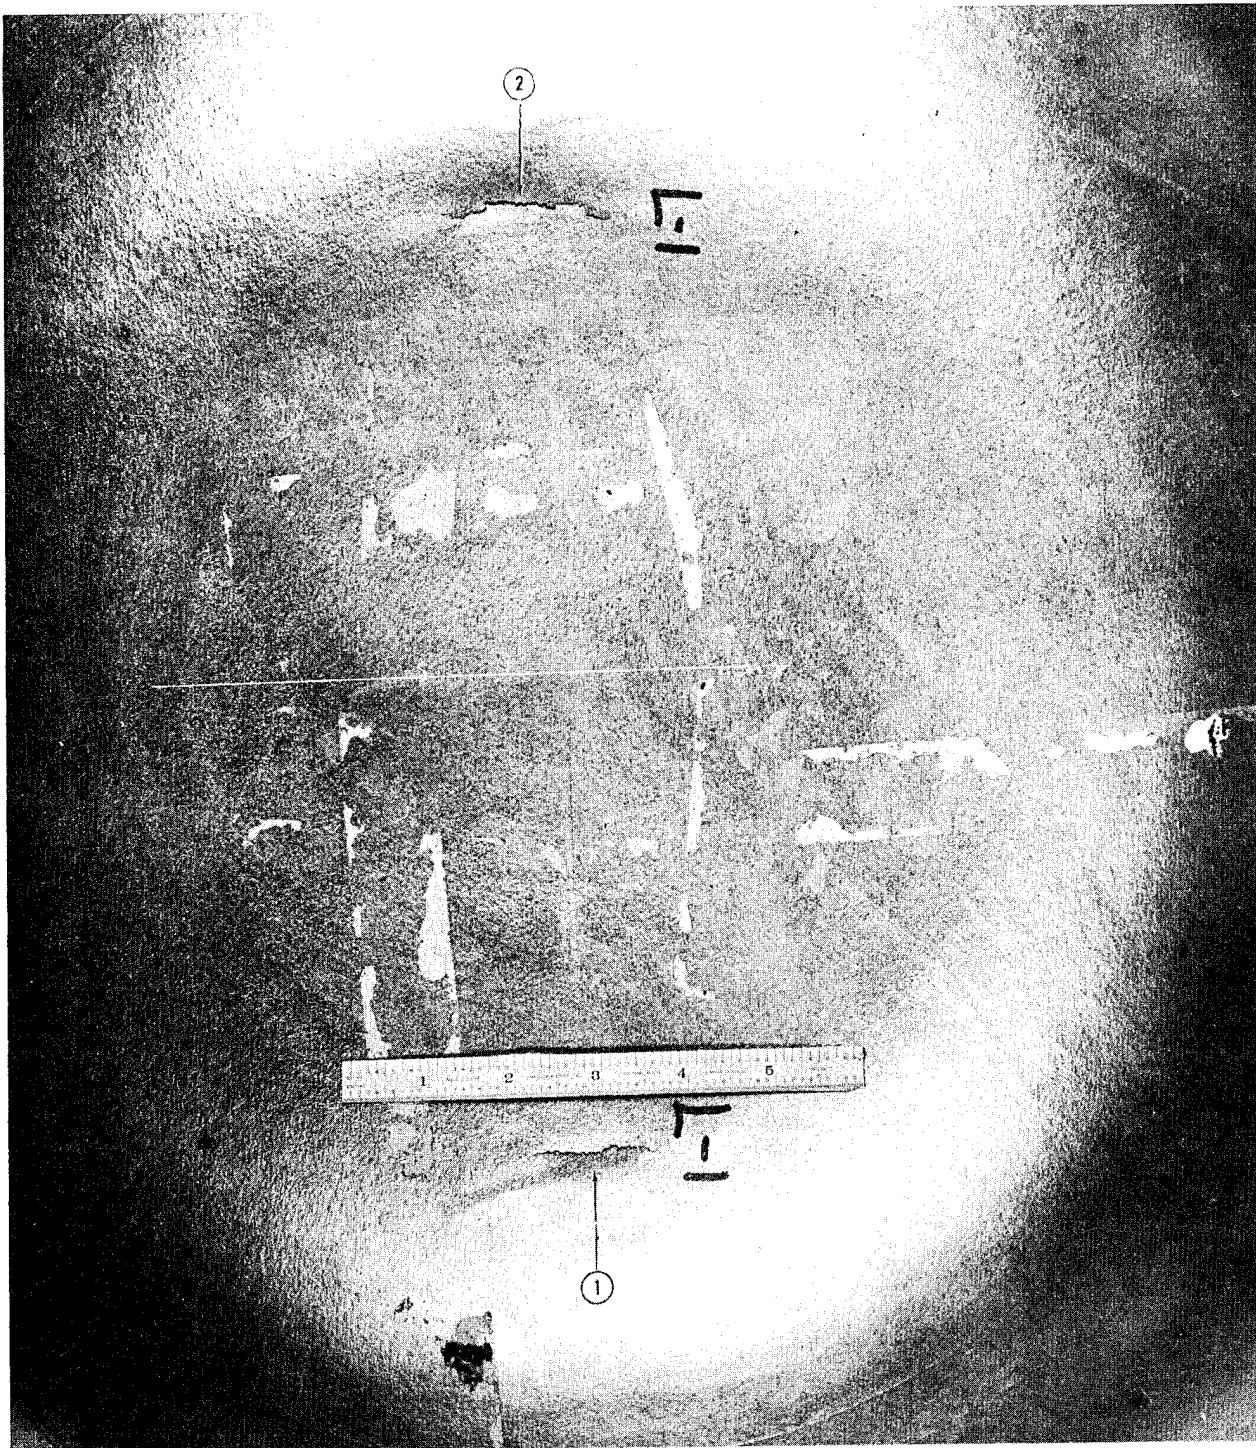
Figure 5 Cracks on the Inside Surface Near the Apex of Dome L1
